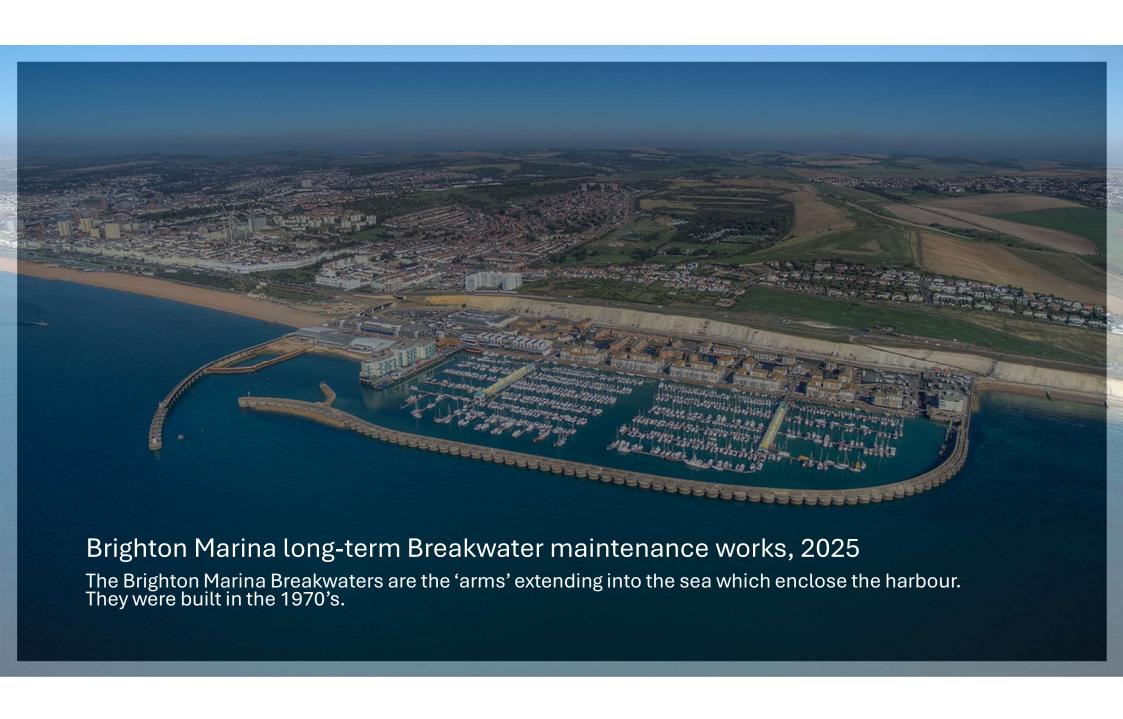
A cross-section of a single caisson. The lower shell, shown red, is less than 300mm thick and formed of reinforced concrete. Initiation of corrosion of the steel in this reinforced concrete means the structure is losing strength as time passes and our maintenance work is to address this problem and extend the life of the structure for many years to come, by changing a lightweight hollow structure into a solid concrete structure. This is achieved by digging out the existing ballast and replacing it with concrete.

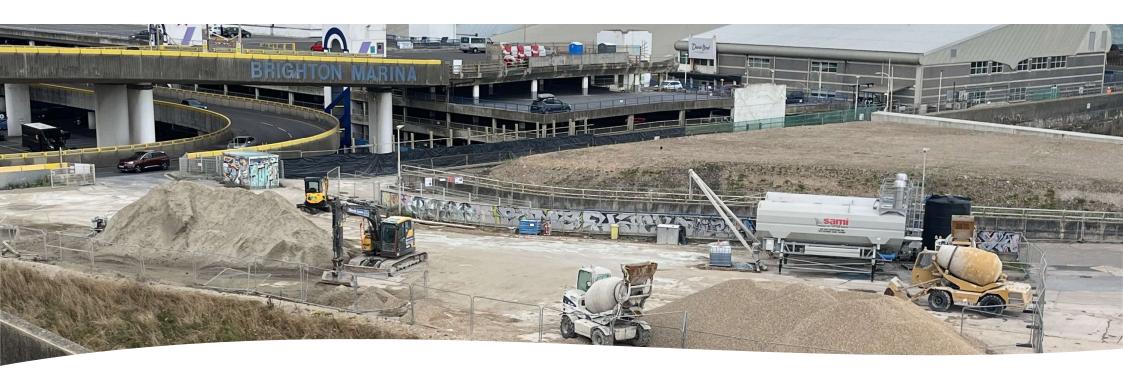
• The contractor has been using Brighton Council's Black Rock site to mix concrete. In this picture you can see small concrete mixers which are filled with ballast extracted from the caissons (left-hand pile), coarse gravel (right-hand pile) and cement from silos to form concrete which is used to fill the caissons.
